# *AmeriSpec Inspection Services*

## Home Inspection Report

1111 Oak Drive Street, Marietta GA, 30144  
Inspection prepared for: John Doe & Jane Smith  
Agent: Your Agent -

Inspection Date: 2/25/2011 Time: 10:00 AM  
Age: 1997 14 Yrs old Size: 1832  
Weather: Rain low 60's

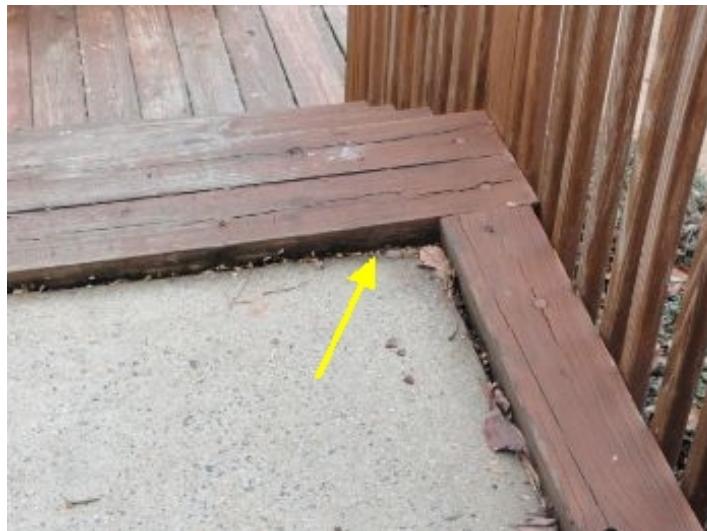
Materials: Concrete  
 Observations:  
 • Possible trip hazard. walkway has settled, This is a safety concern. Suggest repair/replacement as needed to ensure safety.

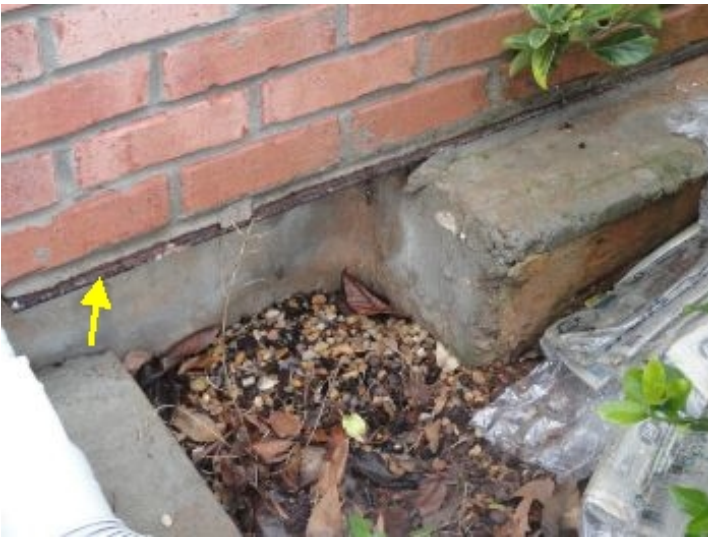
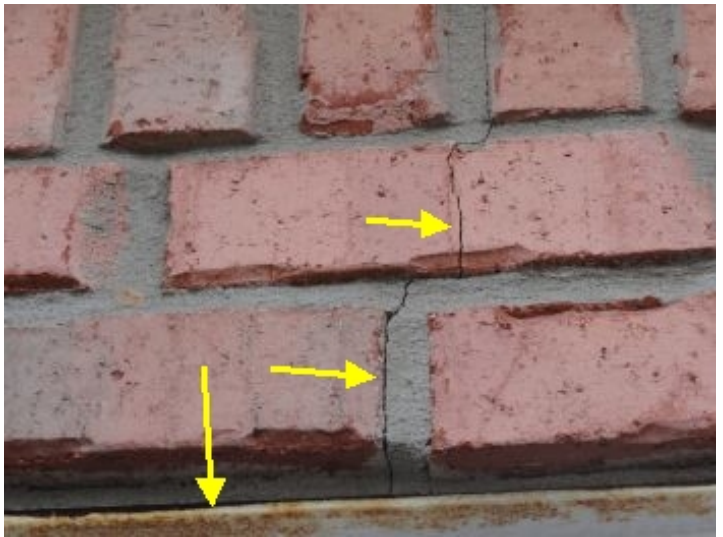
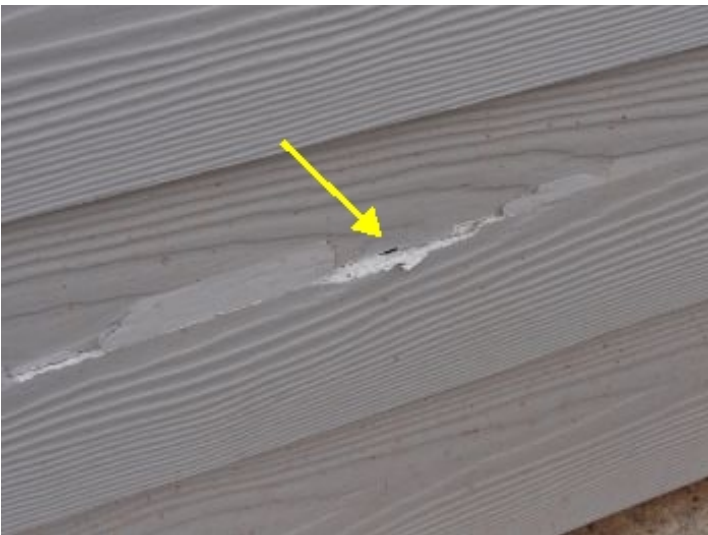
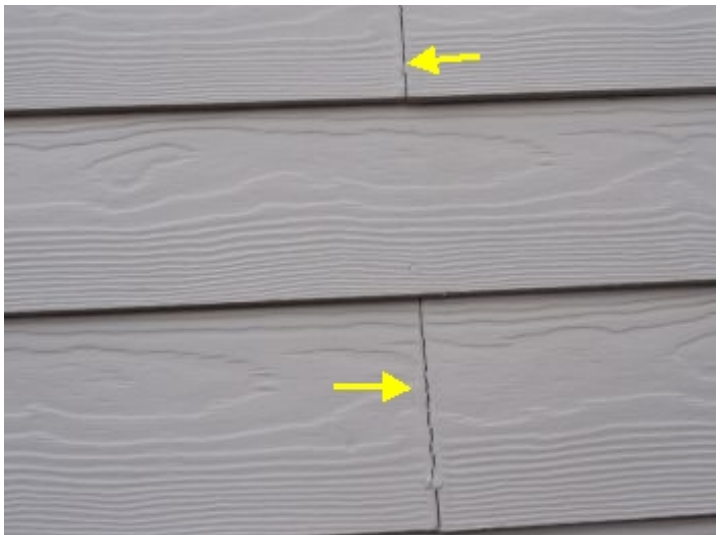
- Minor cracking in brick veneer noted. This is normally not a serious concern. Buyer is advised to monitor this condition and consult with a qualified contractor should condition worsen.
- The caulk has cracked at joints were siding is connected. Caulk is needed to prevent moisture intrusion, this is normal maintenance.
- Areas of minor damage noted.
- Rusted lintel noted at brick ledge at front of house, scrap and paint.
- Suggest trimming back vegetation from siding to prevent deterioration. This will promote moisture damage and wood deterioration to the siding. Our review of this area is limited.

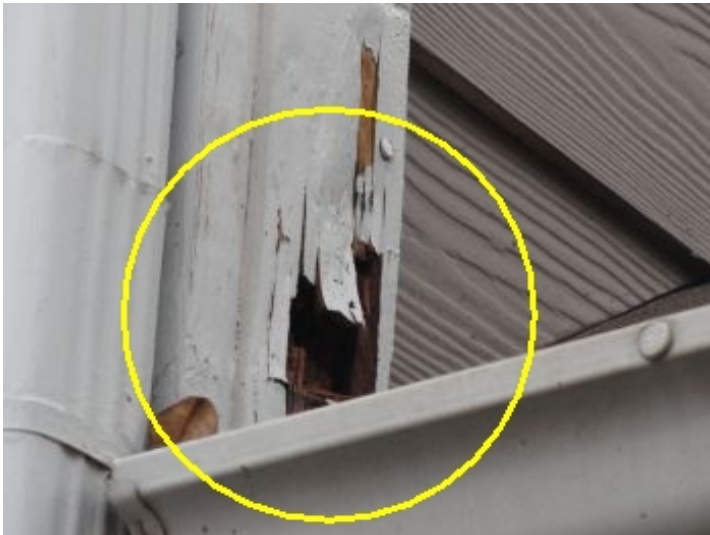
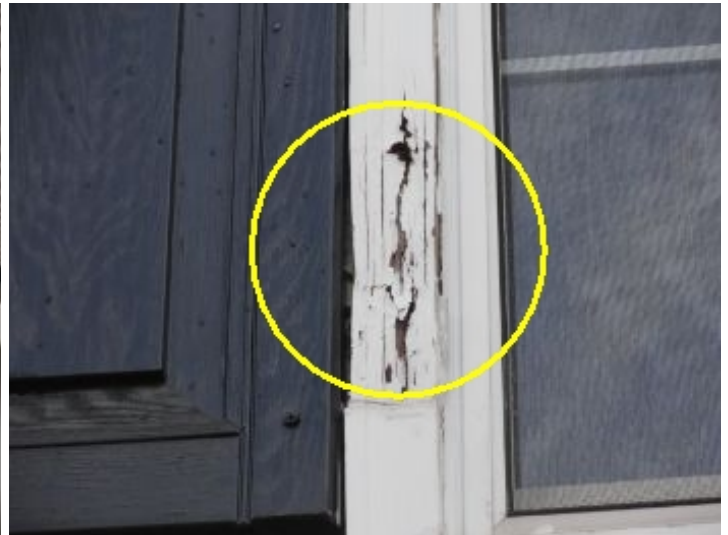
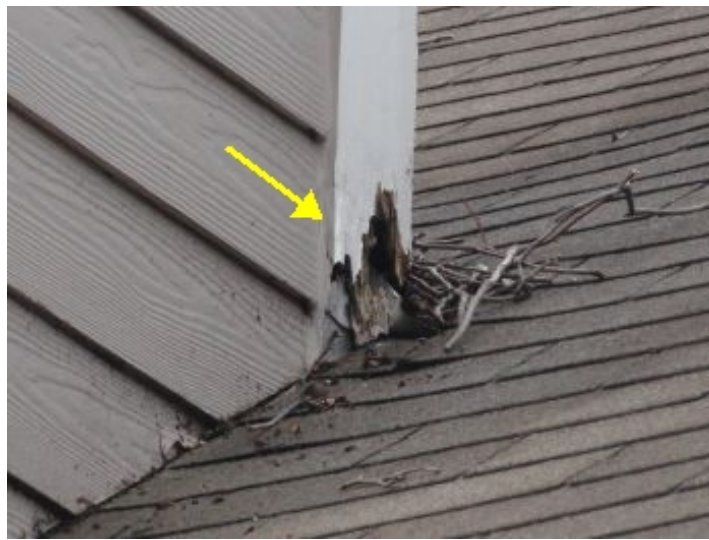
- Moisture damage, wood rot, observed at several doors and windows around the home . Recommend review for repair as necessary.
- Split Caulking and peeling paint noted.

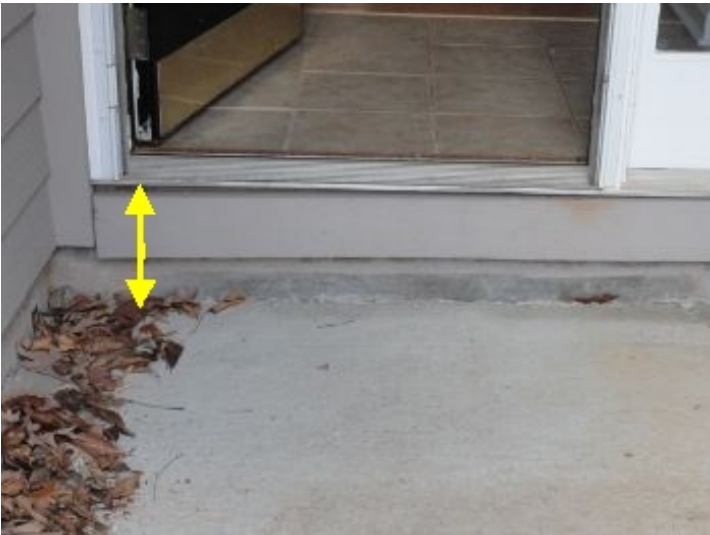
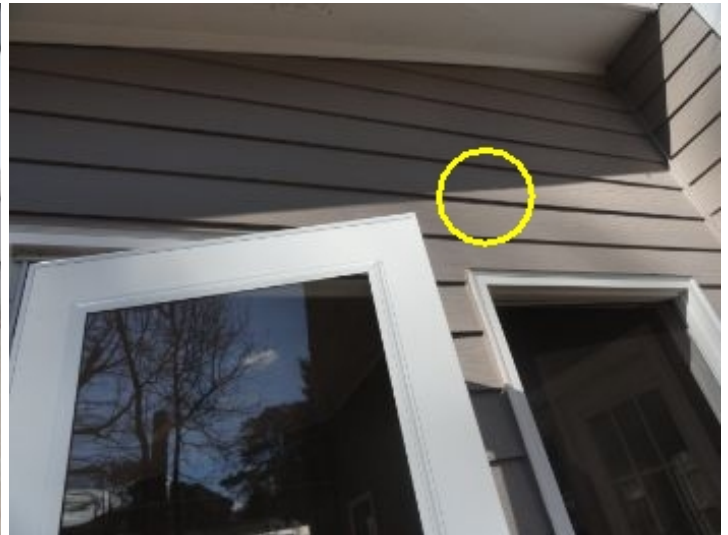
- Step to house from porch is 11 inches, steps should be no higher that 8 inches, this is a trip hazard , repair as needed.
- No light at exterior door, lights are needed for safe egress , have an electrician repair as needed. .

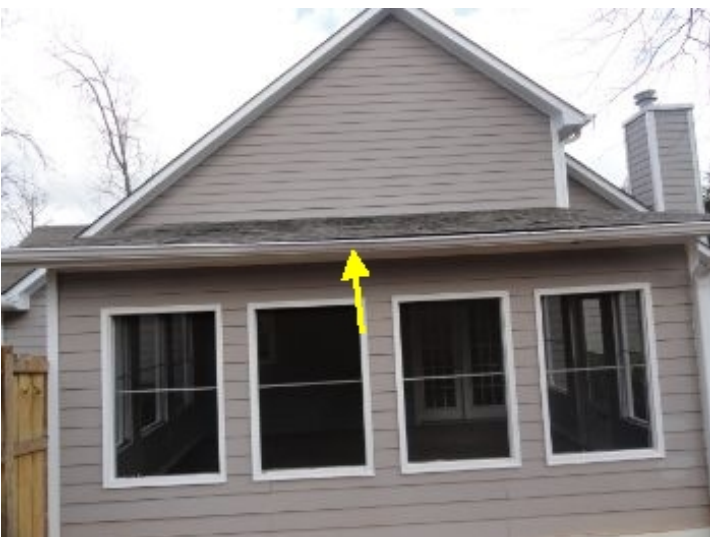
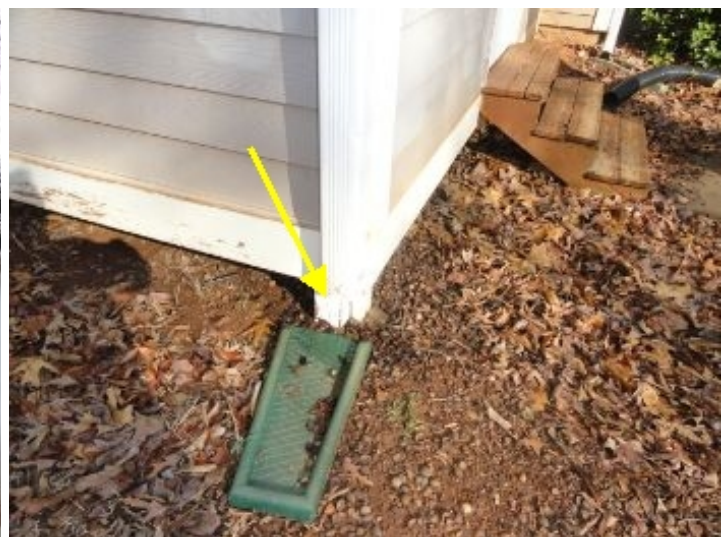
- Suggest gutters be cleaned out as a part of a normal maintenance routine to ensure proper drainage.
- Gutters are sagging, at porch on right side, improperly pitched.
- Splash blocks or extensions are missing on downspouts at various locations around the house. This can result in water accumulating around the structures foundation, (or in basements or crawl spaces, if they exist.) Water can attract wood destroying insects. We recommend extenders so that rain water is moved several feet from the foundation. It is also important that the soil slop down and away from the home to ensure proper drainage
- Elbow missing on gutter downspout at right side. Repairs are needed to ensure proper drainage away from the house.

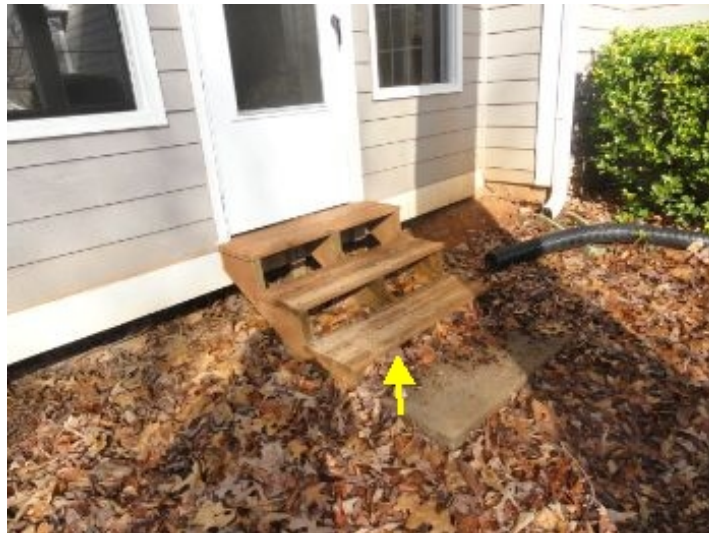
- **Stairs are uneven.**
- **Possible trip hazard. This is a safety concern. Suggest repair/replacement as needed to ensure safety.**

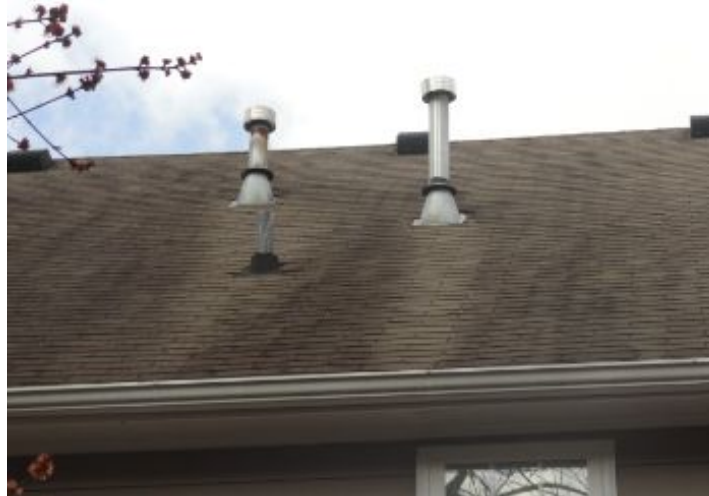
• Granular loss and deterioration observed. Roof appears to be original. This grade of shingles generally lasts 12-17 years. Shingles are dry, brittle, cracked, cupping, and curling. Roof appears to be nearing the end of its useful life. No leaks observed, monitor after each season or major storm.

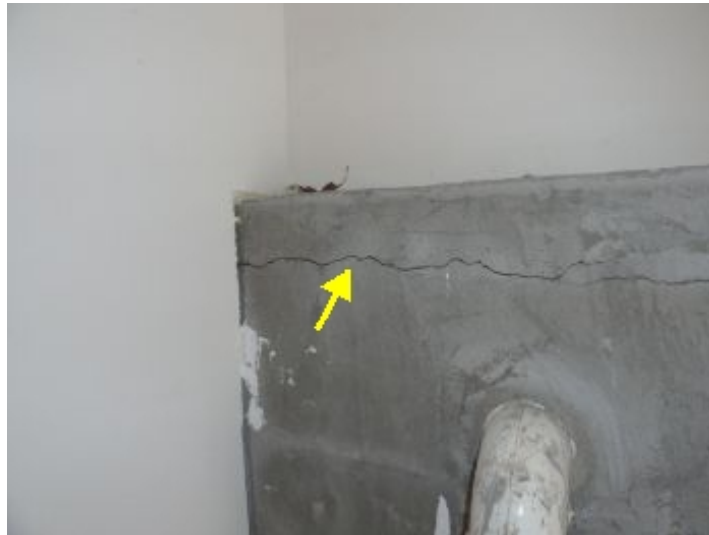
- Common cracks noted.

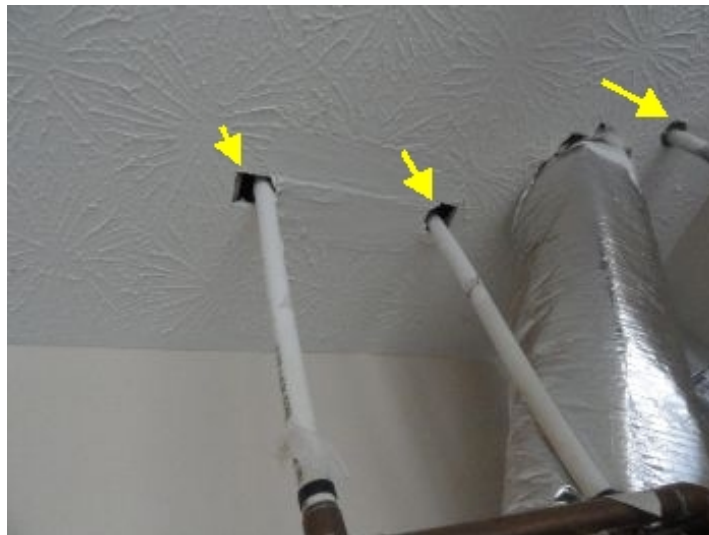
- Fire separation integrity between the house and the garage is compromised due to holes in the ceiling, at water heater. Gypsum board is a good fire barrier and if not present, may cause rapid acceleration of any garage fires into the house. Seal all openings in the ceilings with a fire rated material.

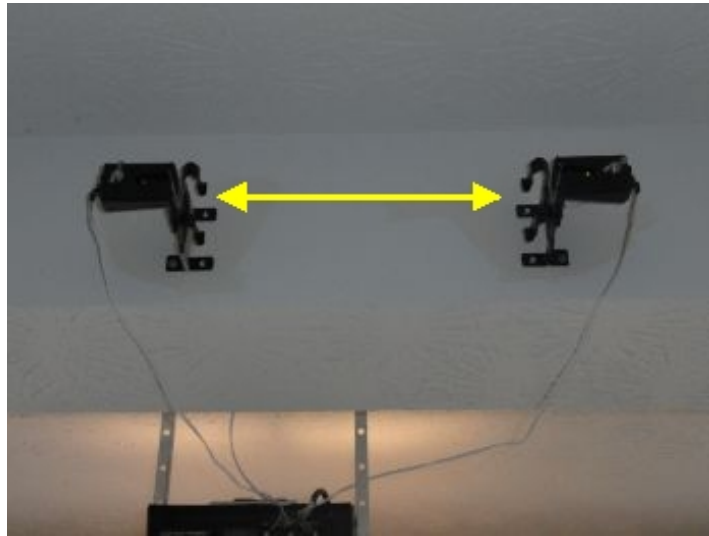
- The electric eyes are mounted too high above the floor to protect small children, pets or property. Lowering these to 6 to 8 inches is recommended by the manufacturer.

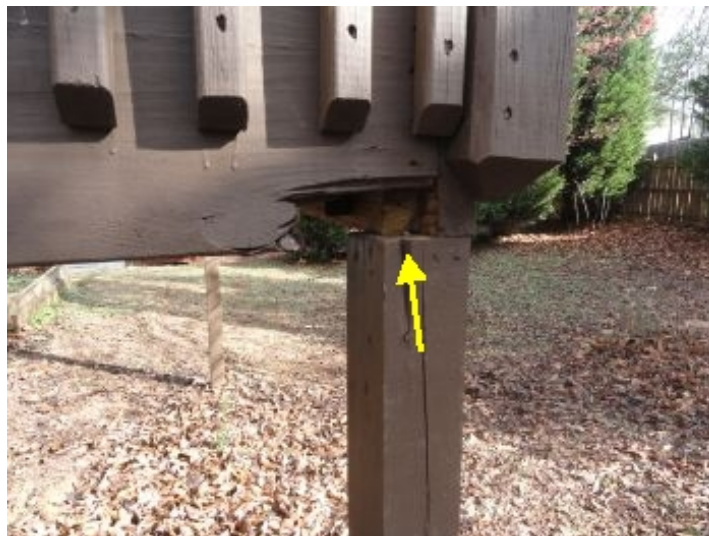
- The handrail is not graspable. Deck stairs require a graspable, continuous and smooth handrail for safety. A 2x4 or 2x6 board is not an acceptable hand rail.
- Deck risers are open, current best practices require openings to be less than four inches, for child safety.
- No required flashing where deck meets house, as required. Flashing is a suitable thin metal used to prevent water penetration in joints and tight areas around bolts. (R703.6).
- Outside beam is damaged at left side, have a deck contractor repair prior to use.

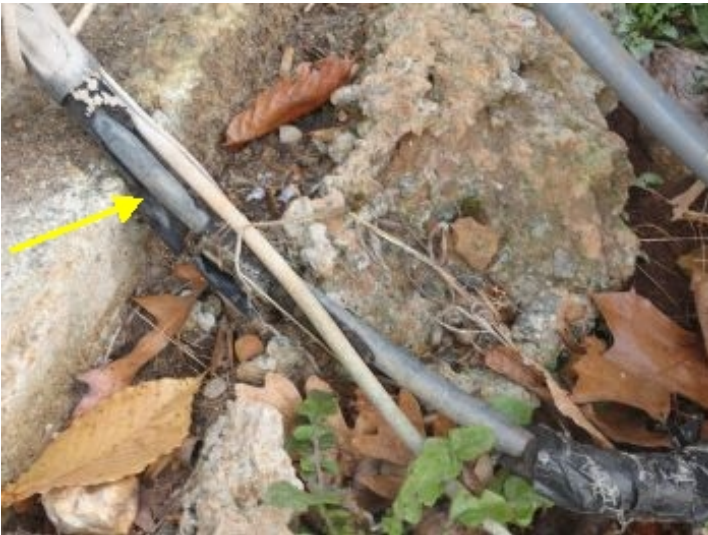
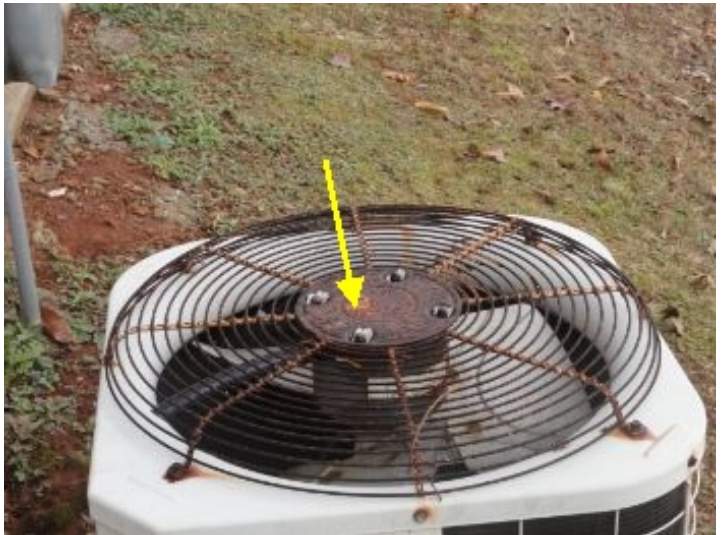
- Refrigerant line insulation is damaged. Recommend repairs for improved performance
- A/C cabinet is original and is 14 years old; It is near or at the end of its useful service life. Minimal life should be expected from this unit. Normal life in this area for an outside condenser is 12-15 years.

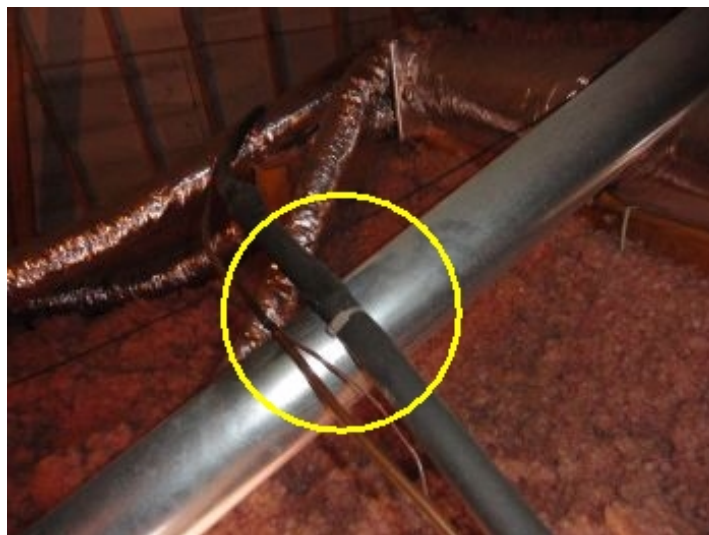
- Grommets or protective bushings are needed to protect the thermostat wires when they pass through the metal furnace walls. We recommend adding this protection for proper operation.
- The refrigerate lines in the attic were not properly supported, the line should be supported every 6 feet, add supports as needed.

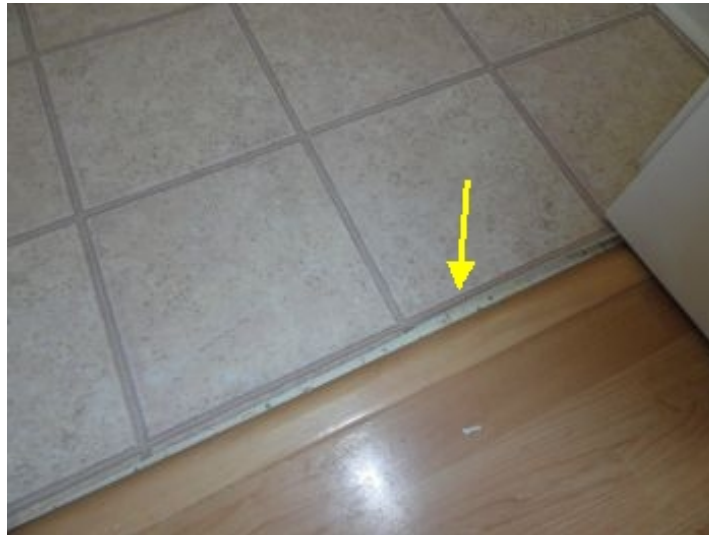
- Minor damage noted, not sealed at door.

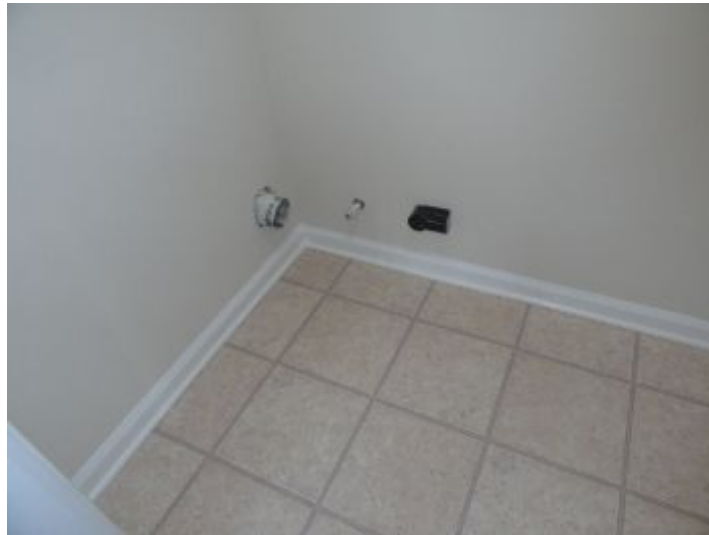
- No pan was installed for the washer, these are recommended when the laundry is located over finished space

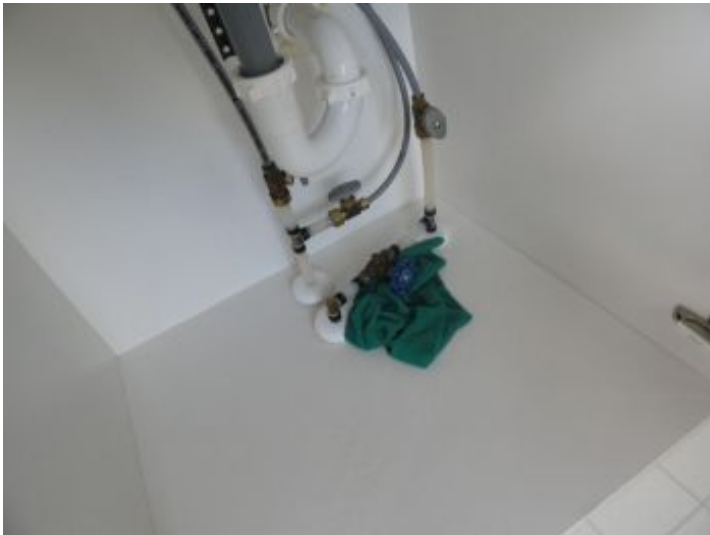
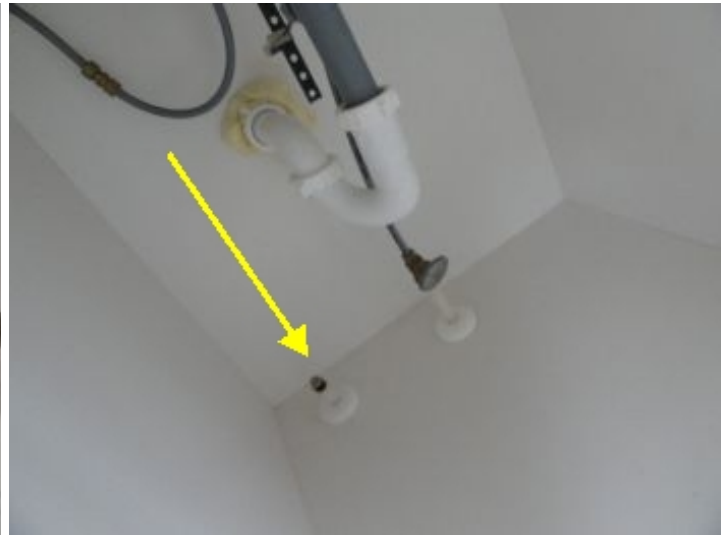
Observations:  
 • Right side sink in master is connected from left sink.

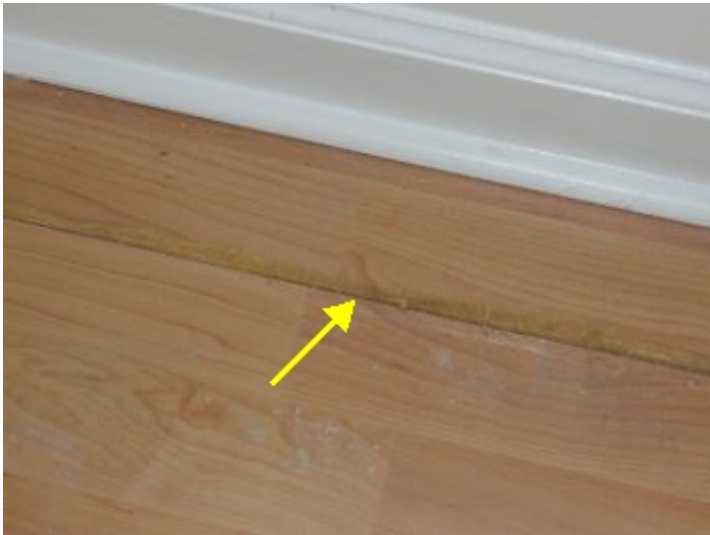
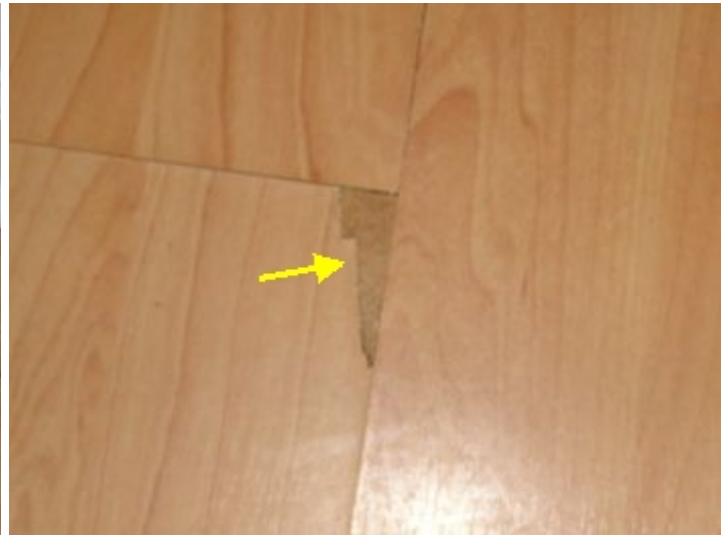
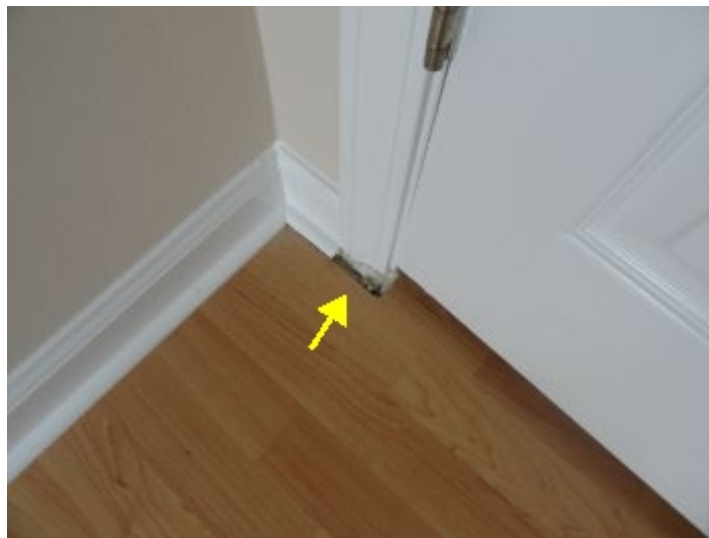
- Water damage observed.
- Minor damage noted.
- Non professional installation noted in upstairs bedrooms, repair as needed
- Floor trim at lower level between tile and pergo floor is loose and needs secured

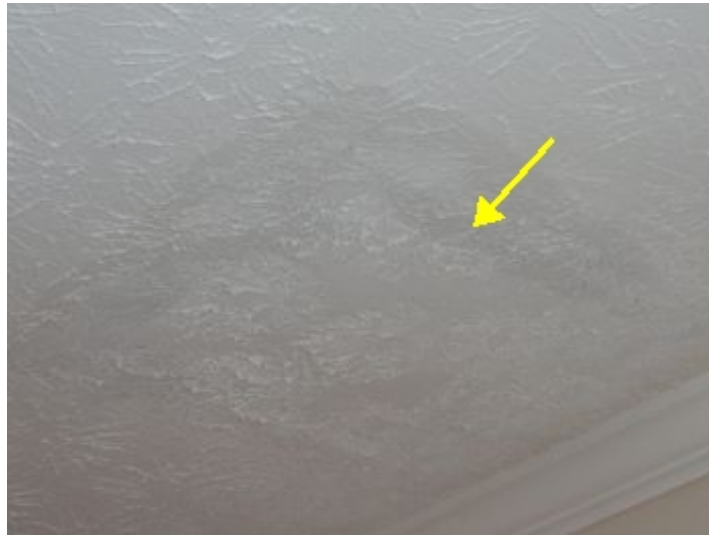
- Common cracks noted, the cracks do not represent a condition that is in need of attention, No water stains observed at the time of the inspection.
- Evidence of past water penetration observed.
- Water stains, at the time of the inspections, or other damage was observed near plumbing fixtures that indicate leaks or possible concealed leaks. Client is advised to obtain further review by a licensed plumber prior to closing to determine the cause of this condition for repairs/replacement as needed.

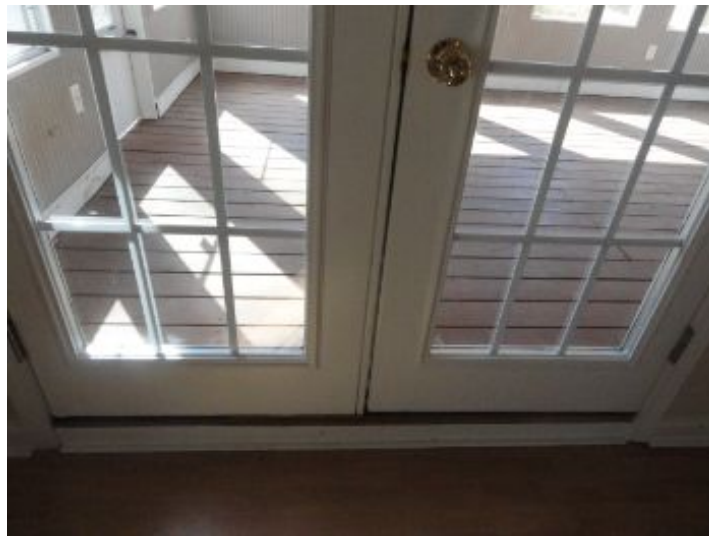
- Door sticks at upstairs bedroom, does not close, needs adjustment.
- Weather stripping missing or damaged at deck door, repair as needed.

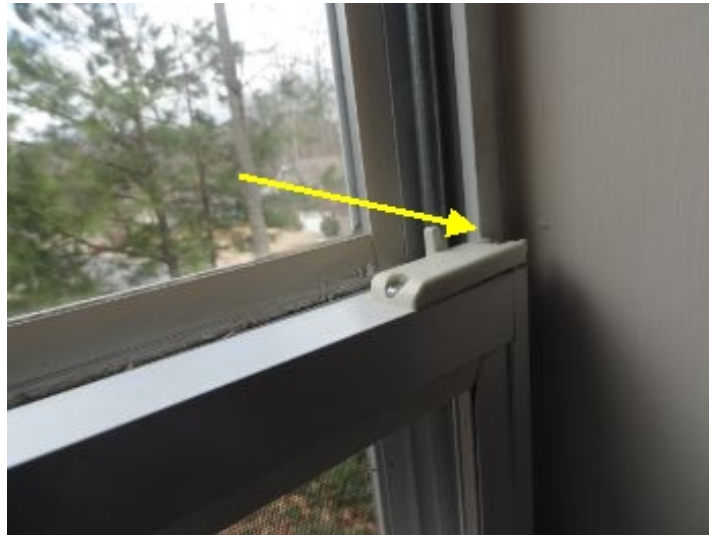
- Window locks or other hardware damaged at upstairs Bedroom . Repairs are needed for proper operation and safety.

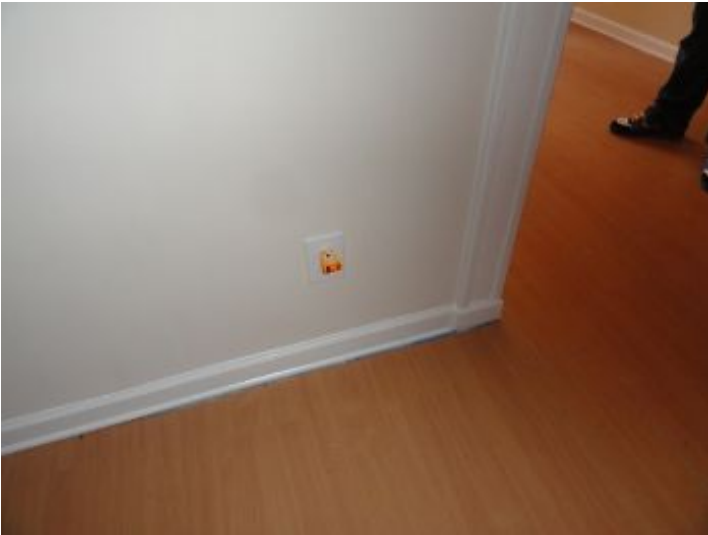
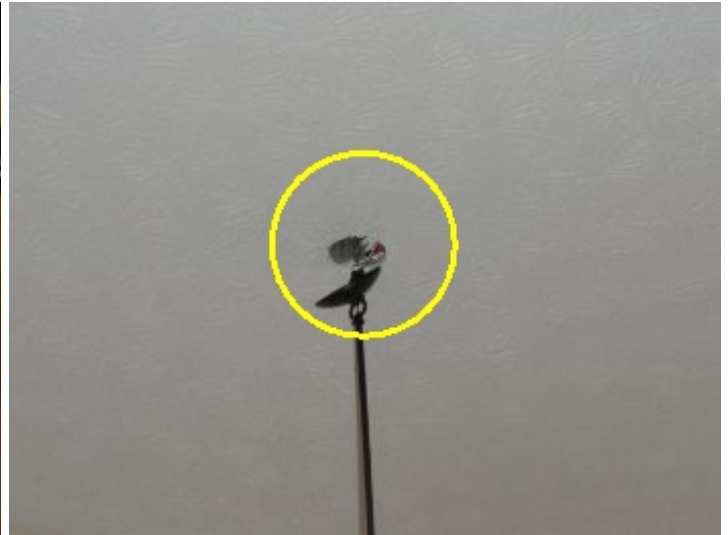
- Open ground noted at lower level receptacles observed at office area have an electrician repair for safety.
- Over head light loose in living room, have an electrician repair as needed

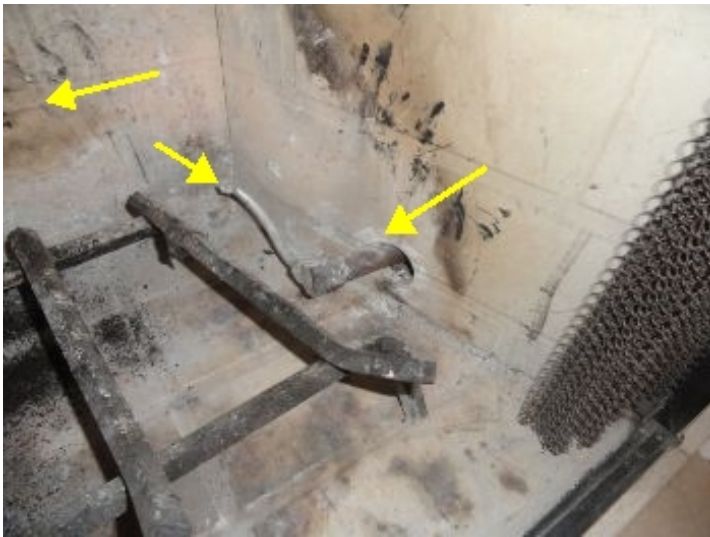
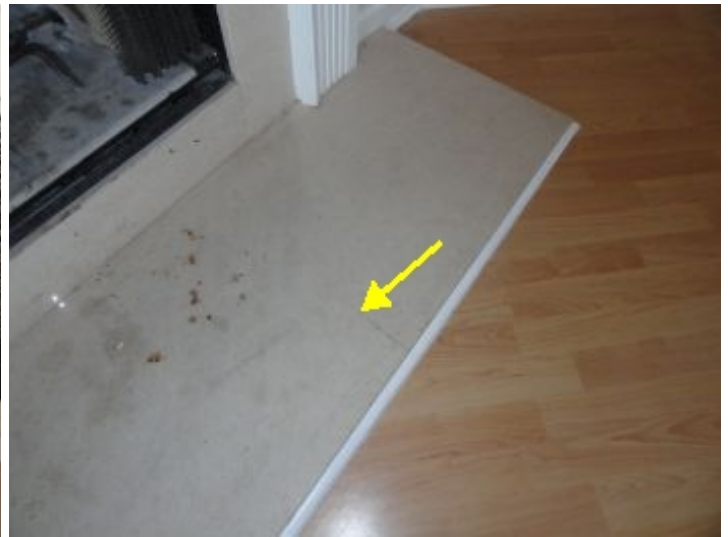
- A wood burning fireplace is noted in this home.
  - The gap around the gas supply line where entering the side of the fireplace needs to be sealed with heat resistant compound or refractory cement that has been properly cured as required by industry standards. This is a safety concern. We recommend a qualified professional review the gas entry line and make repairs as needed.
  - Minor cracking and deterioration on back fire brick, no fire brick on sides of firebox, given the age and visible condition we recommend a professional chimney evaluation prior to wood burning use of this fireplace for safety.
  - Uncapped gas line for starter or previously installed gas logs noted.
- Correction needed
